# Manhole Inspection Summary

Manhole # S31EE1001MH

Insp Date: **3/19/07 2:35 PM**

**Location** Address: **113 UNIVERSITY BLVD**

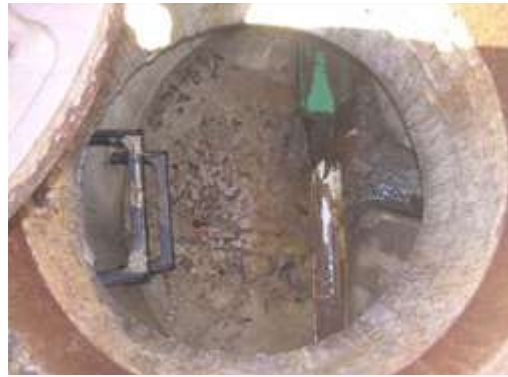
Top View

☒ **Debris** (not Condition related)

Bench debris.

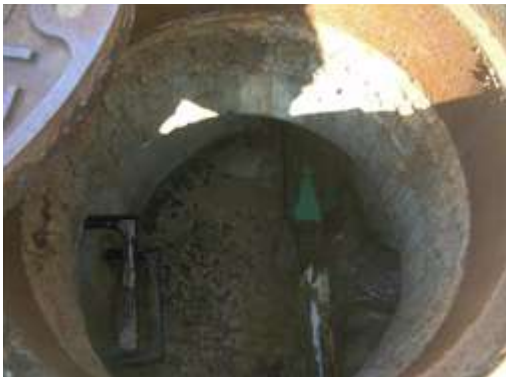
Defect

☒ **Leaks**

Infiltration: ☐ None ☒ **Joint** ☐ Cracks ☐ Mortar ☐ Roots ☒ **Wall**

Infiltration: ☐ None ☒ **Joint** ☐ Cracks ☐ Mortar ☐ Roots ☐ Wall

Frame leaks. Adjustment and Barrel infiltration.

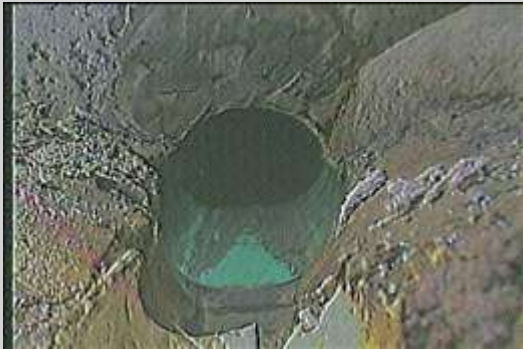
### 8 in. Circular Gravity Sewer Pipe Out @ 12 O'Clock

Infiltration: **Evidence** Pipe Seal Cond: **Unknown**

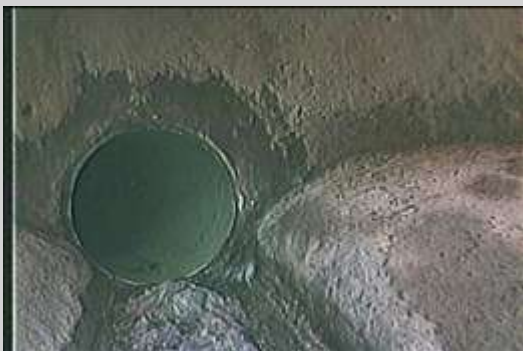
### 6 in. Circular Gravity Sewer Pipe In @ 4 O'Clock

Infiltration: **Evidence** Pipe Seal Cond: **Unknown**

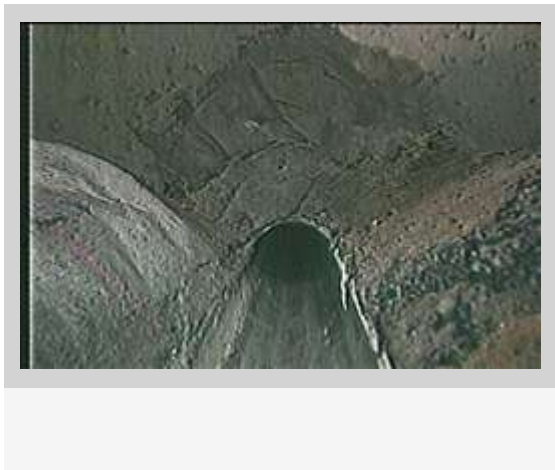
4 in. Circular Gravity Sewer  
Pipe In @ 6 O'Clock

Infiltration: **Evidence** Pipe Seal Cond: **Cracked**
